**ILLINOIS ENVIRONMENTAL PROTECTION AGENCY  
MEMORANDUM**

**DATE:** 11 August 2011

**SUBJECT:** LPC #1198010003 – Madison County  
Hartford/Chemetco  
FOS File

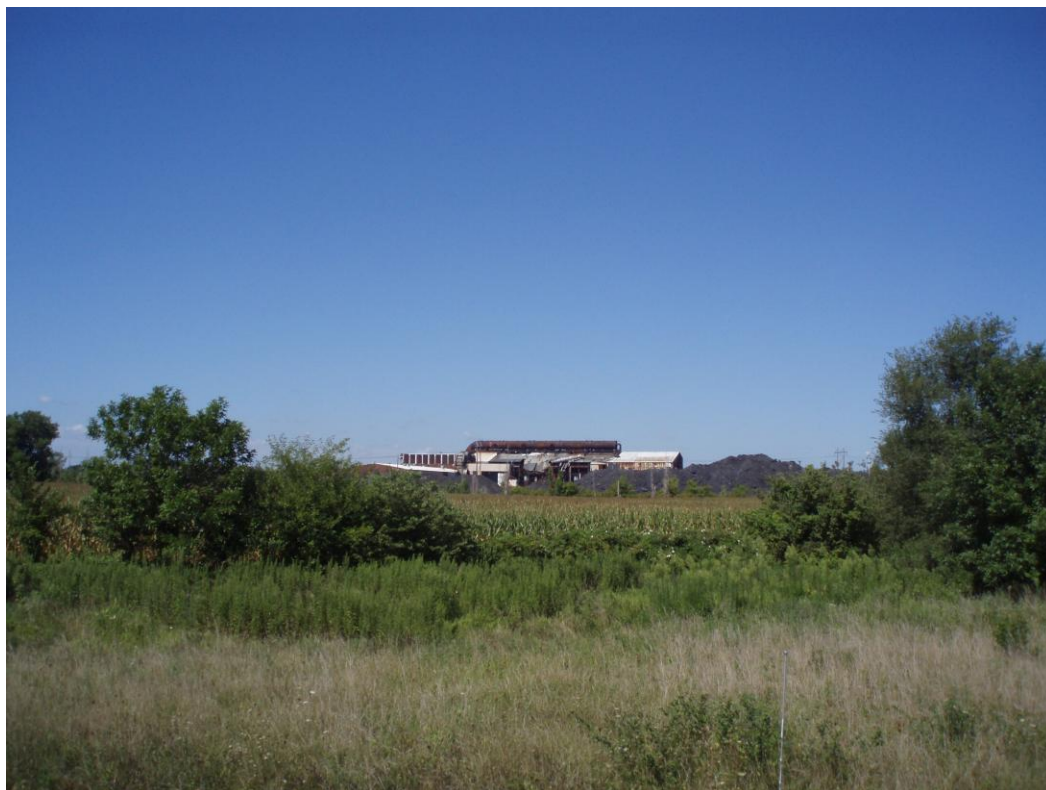
**Date:** 11 August 2011  
**Time:** 10:37 a.m.  
**Direction:** W  
**Photo by:** M. Cozadd  
**Exposure #:** 001  
**Comments:** Overview of site.

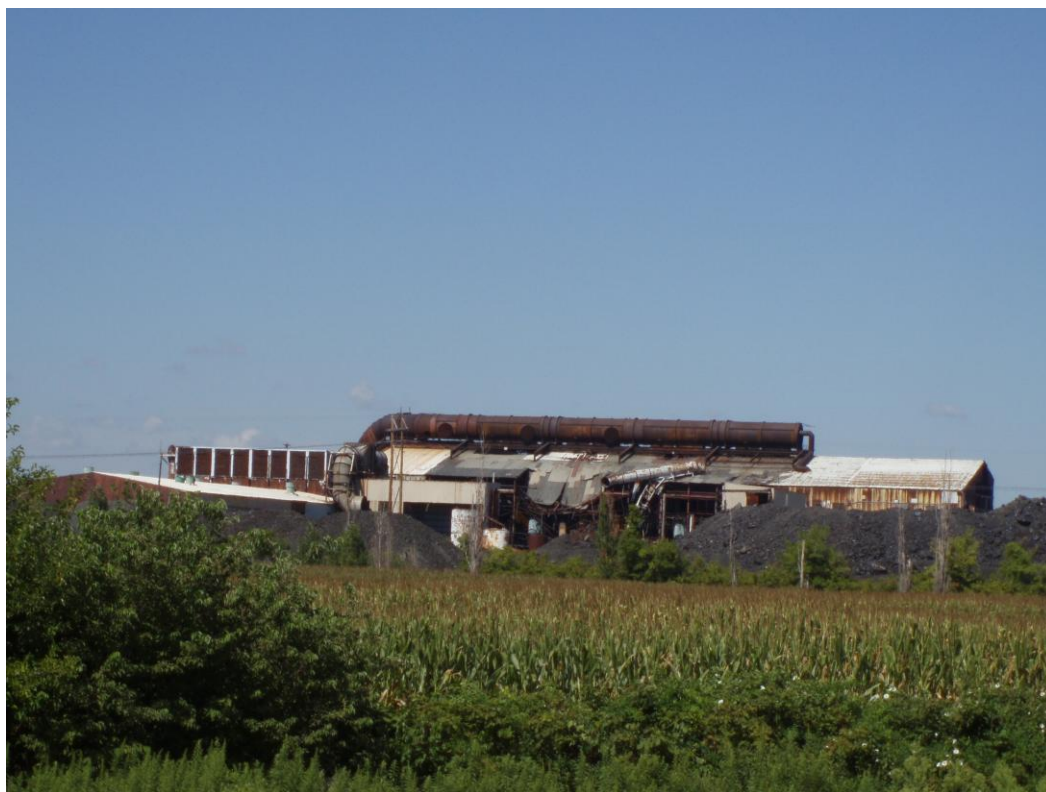
**Date:** 11 August 2011  
**Time:** 10:37 a.m.  
**Direction:** W  
**Photo by:** M. Cozadd  
**Exposure #:** 002  
**Comments:** Overview of site.

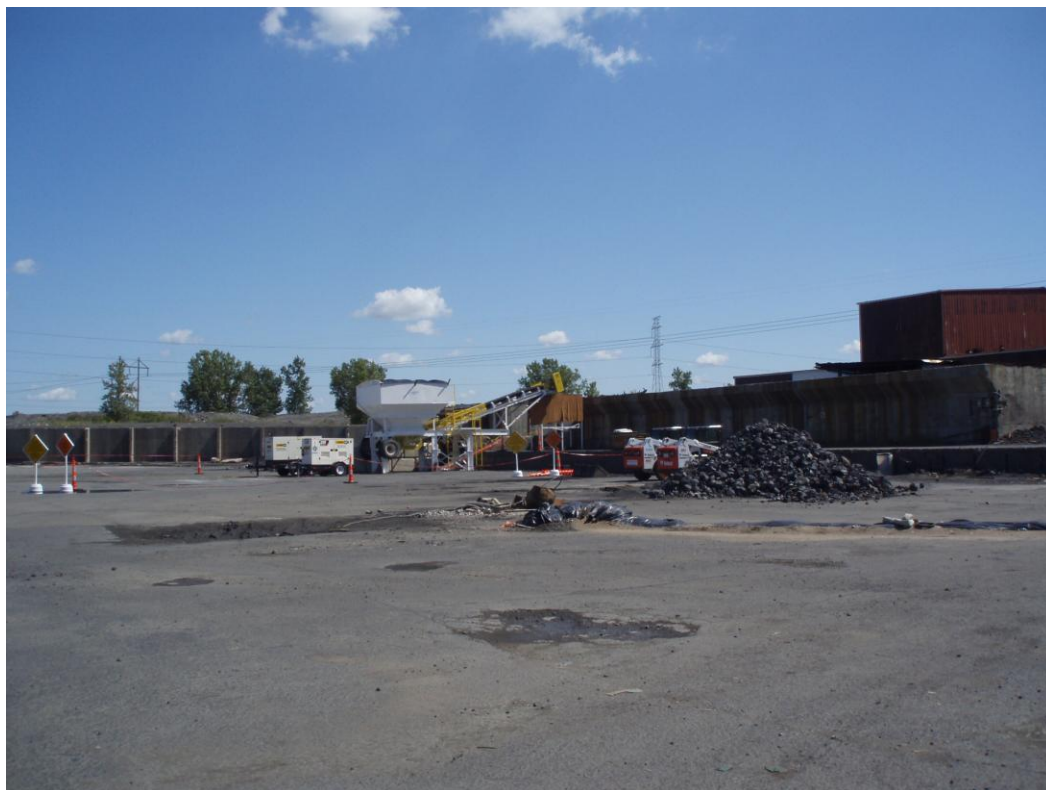
**Date:** 11 August 2011  
**Time:** 10:56 a.m.  
**Direction:** NE  
**Photo by:** M. Cozadd  
**Exposure #:** 003  
**Comments:** Hopper to  
load scrubber sludge  
from DIS Building.

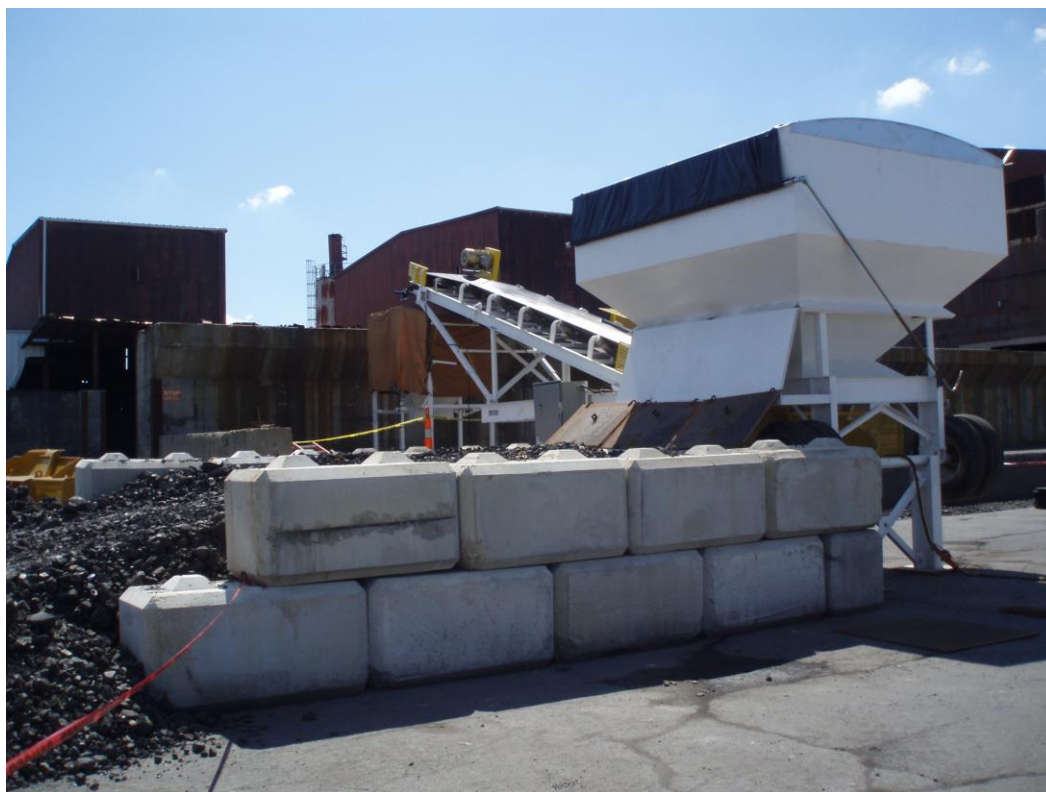
**Date:** 11 August 2011  
**Time:** 11:02 a.m.  
**Direction:** SE  
**Photo by:** M. Cozadd  
**Exposure #:** 004  
**Comments:** Hopper to  
load scrubber sludge  
from DIS Building.

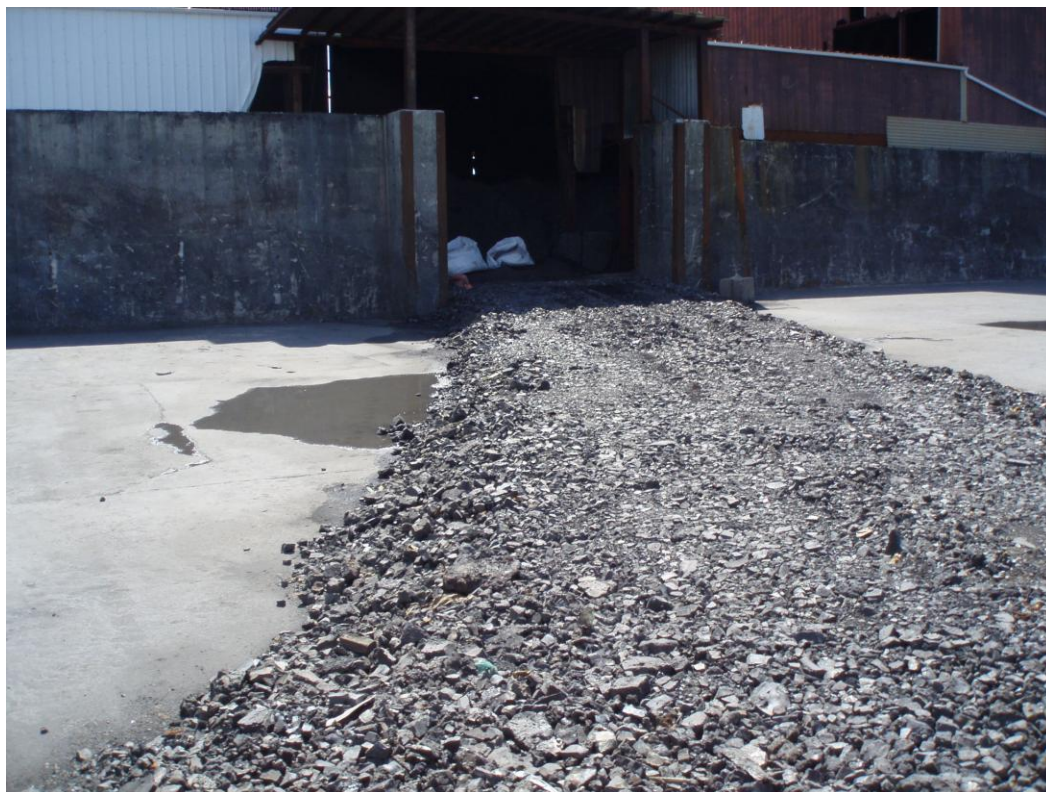
**Date:** 11 August 2011  
**Time:** 11:04 a.m.  
**Direction:** E  
**Photo by:** M. Cozadd  
**Exposure #:** 005  
**Comments:** Slag road  
from DIS Building to  
hopper.

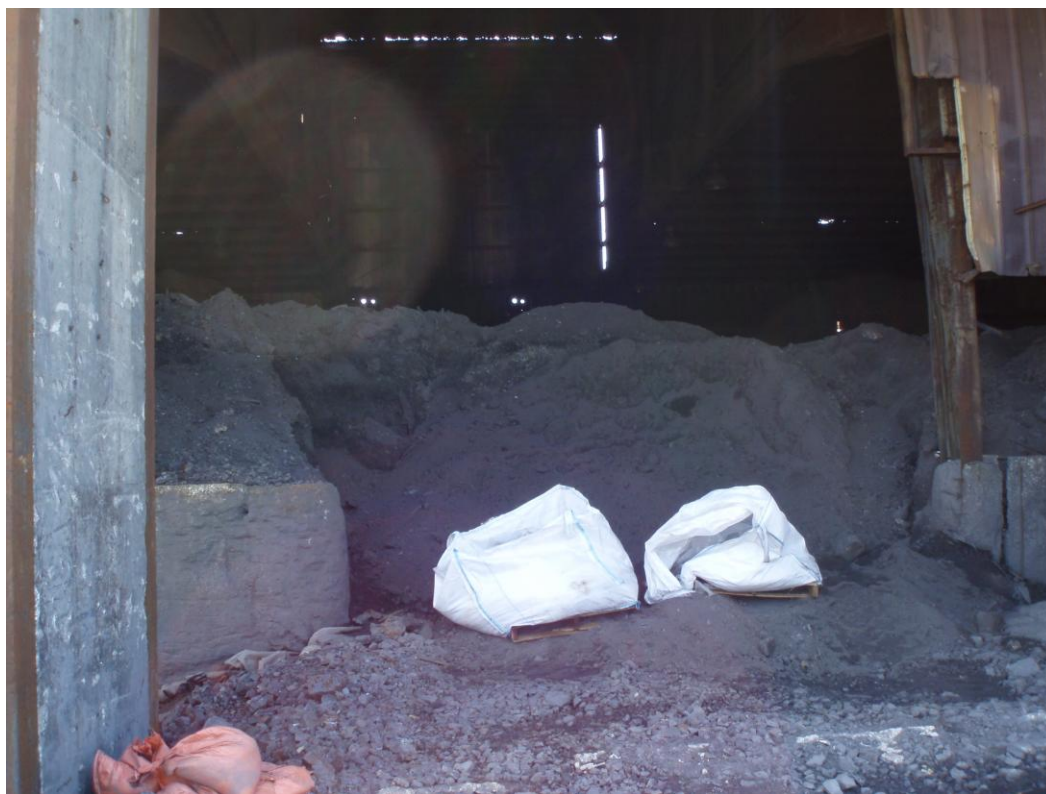
**Date:** 11 August 2011  
**Time:** 11:05 a.m.  
**Direction:** E  
**Photo by:** M. Cozadd  
**Exposure #:** 006  
**Comments:** Scrubber  
sludge in DIS Building.

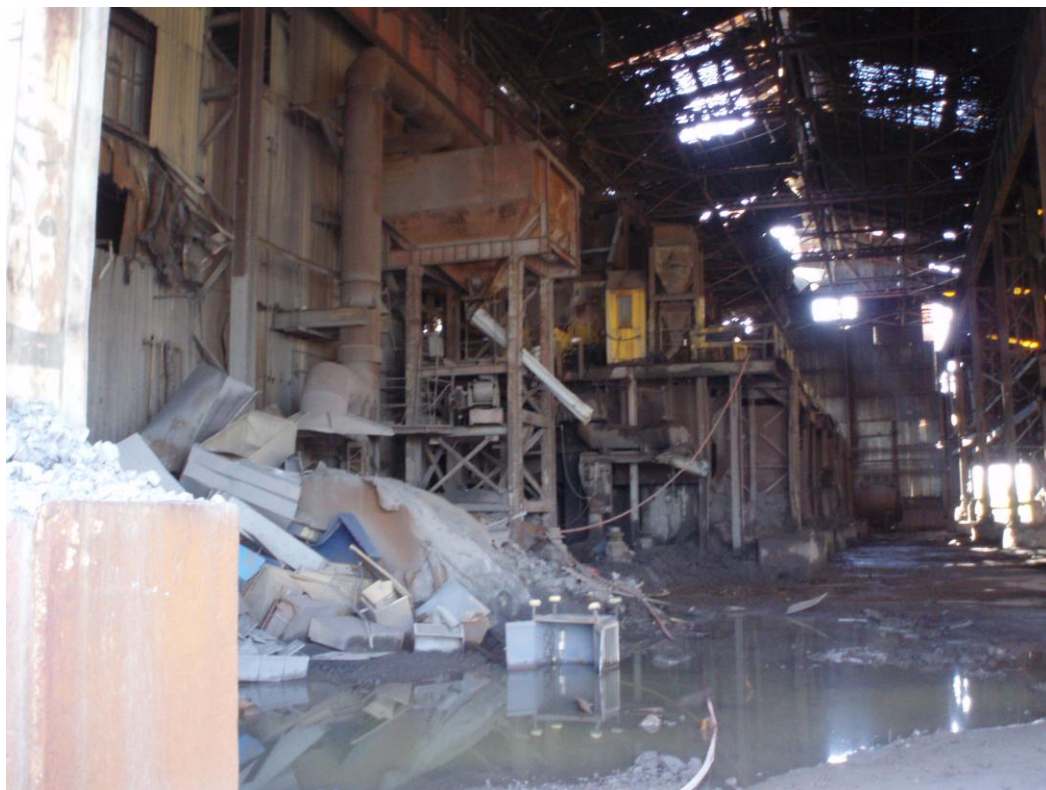
**Date:** 11 August 2011  
**Time:** 11:13 a.m.  
**Direction:** S  
**Photo by:** M. Cozadd  
**Exposure #:** 007  
**Comments:** Interior of Foundry Building as seen from doorway.

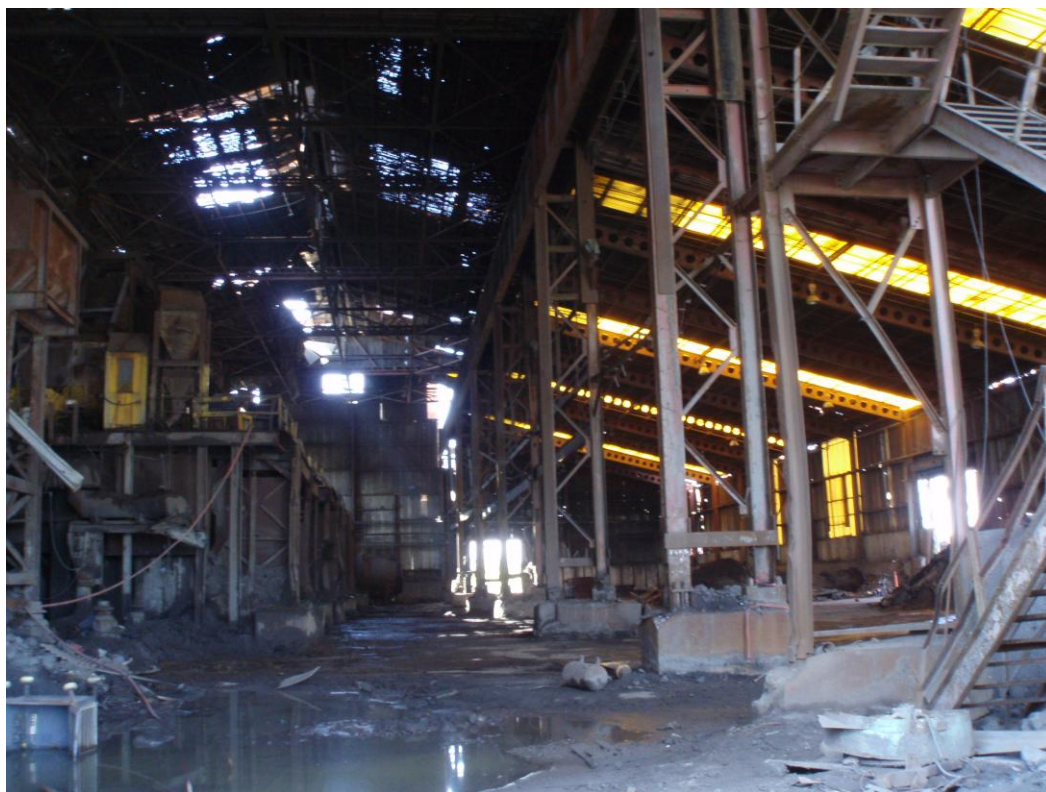
**Date:** 11 August 2011  
**Time:** 11:13 a.m.  
**Direction:** S  
**Photo by:** M. Cozadd  
**Exposure #:** 008  
**Comments:** Interior of Foundry Building as seen from doorway.

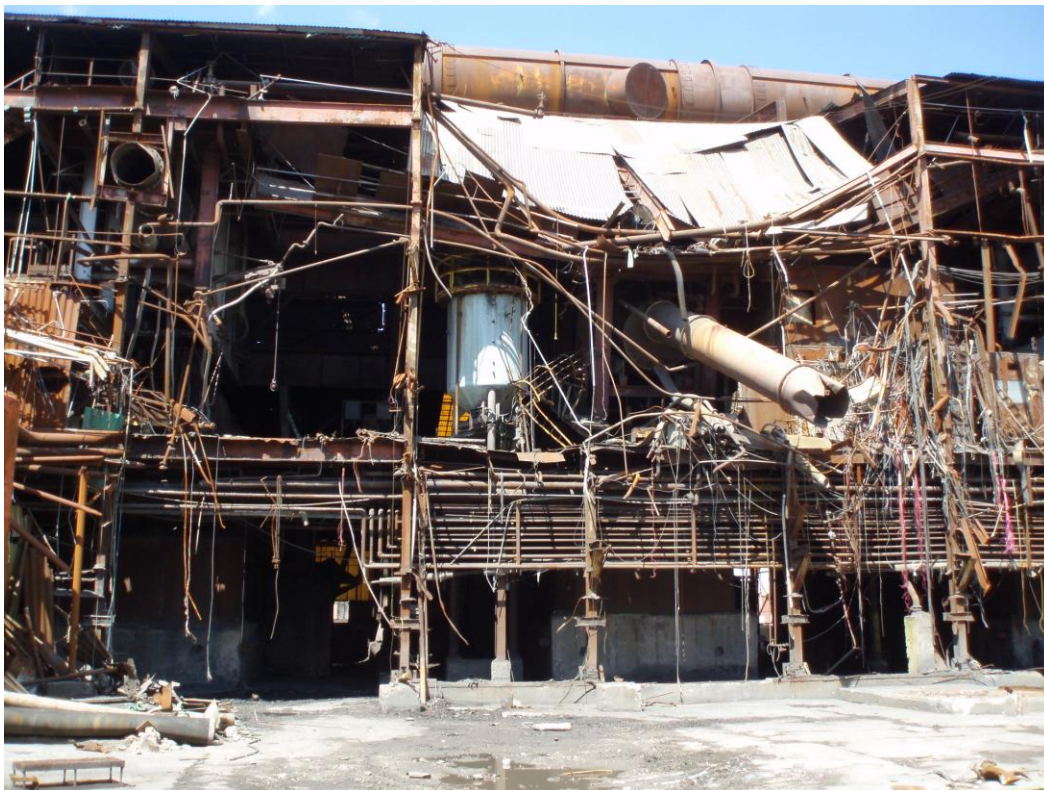
**Date:** 11 August 2011  
**Time:** 11:22 a.m.  
**Direction:** W  
**Photo by:** M. Cozadd  
**Exposure #:** 009  
**Comments:** East side of Foundry Building.

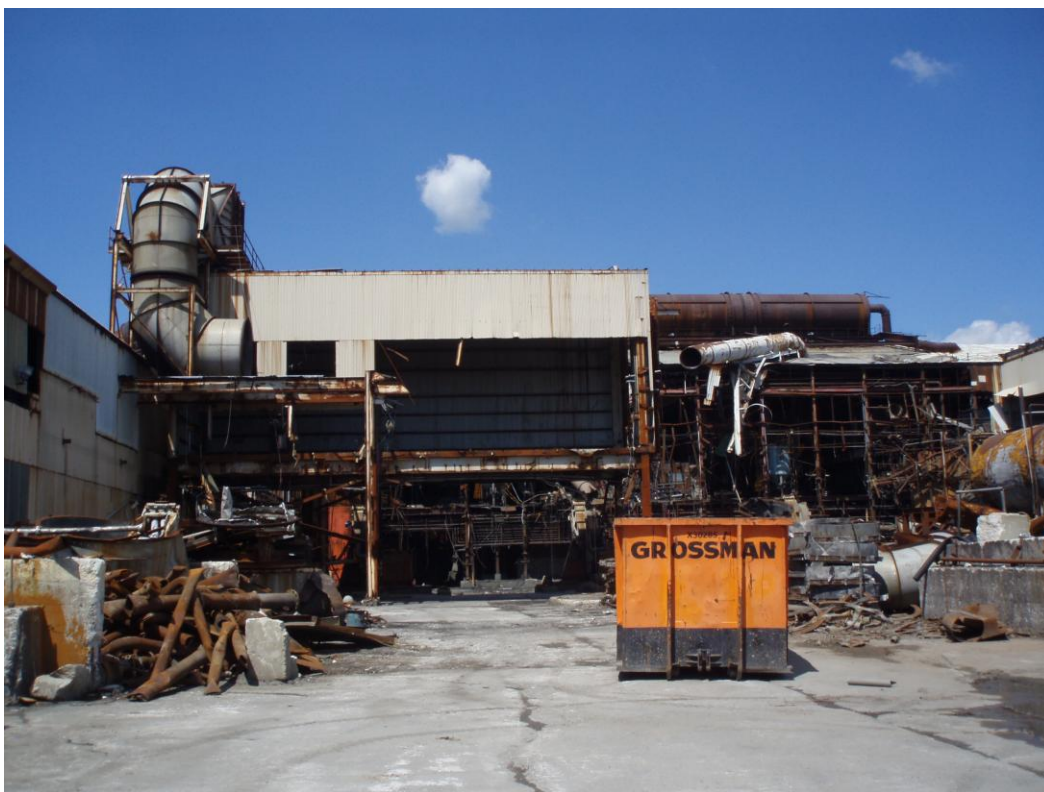
**Date:** 11 August 2011  
**Time:** 11:24 a.m.  
**Direction:** W  
**Photo by:** M. Cozadd  
**Exposure #:** 010  
**Comments:** East side of Foundry Building.

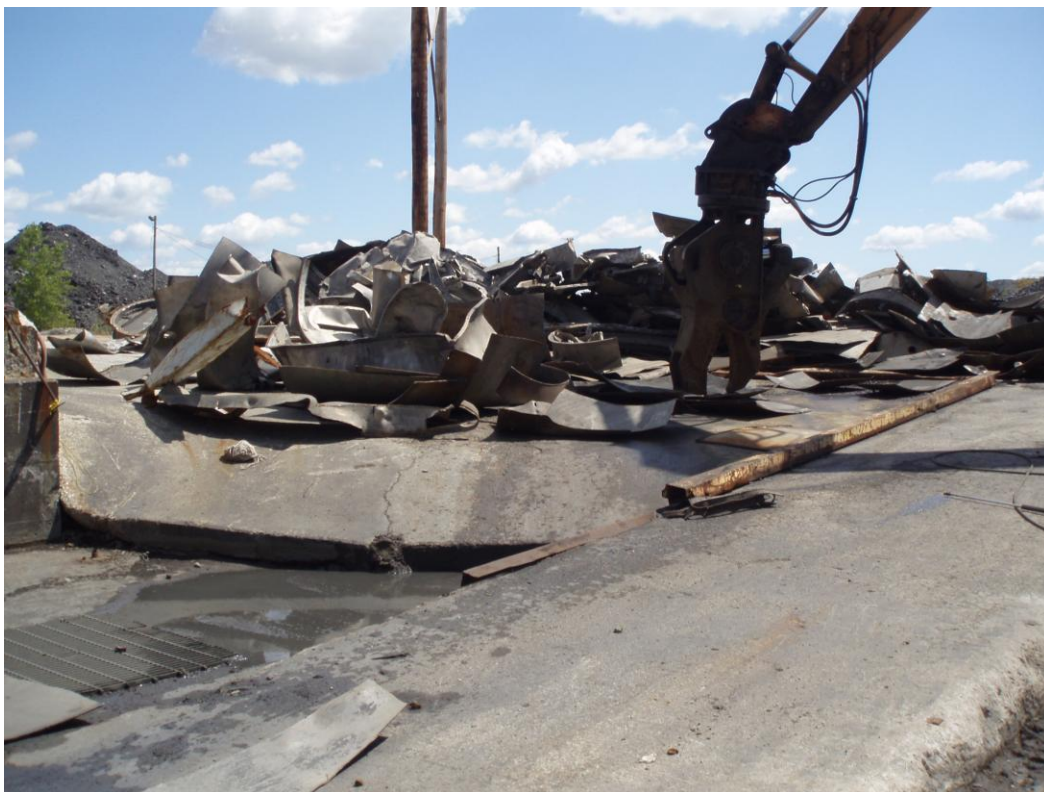
**Date:** 11 August 2011  
**Time:** 11:24 a.m.  
**Direction:** NE  
**Photo by:** M. Cozadd  
**Exposure #:** 011  
**Comments:**  
Decontamination area  
north of Tank House.

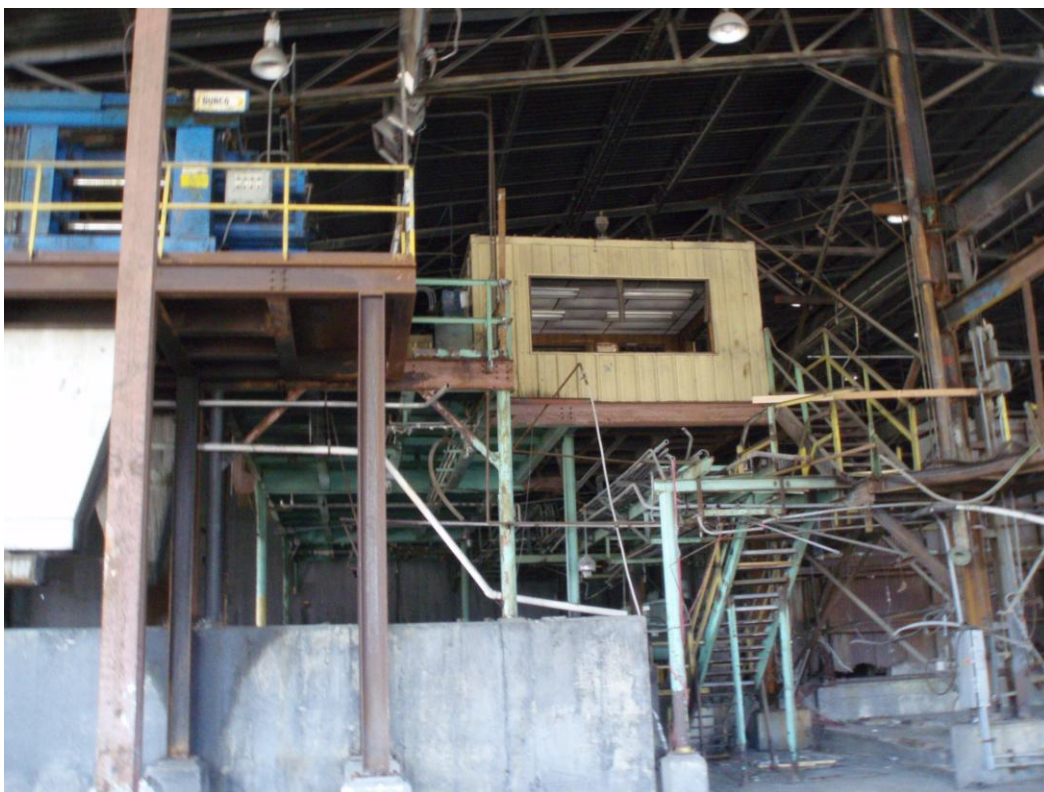
Asbestos abatement of the offices in the Foundry Building and the Tank House is being conducted by Advanced Environmental Services (AES). The attached photo #012 shows the view of the second floor offices under asbestos abatement. The photograph was taken from the first floor. The demolition debris from the offices in the Tank House is shown in the attached photo #015. I requested photographs from Mr. Murray showing the asbestos abatement in the offices in the Tank House and the Foundry Building. The photographs were received via electronic mail from Mr. David Herrera on August 22, 2011.

**Date:** 11 August 2011  
**Time:** 11:27 a.m.  
**Direction:** W  
**Photo by:** M. Cozadd  
**Exposure #:** 012  
**Comments:** View of  
second floor offices  
under asbestos  
abatement in Tank  
House.

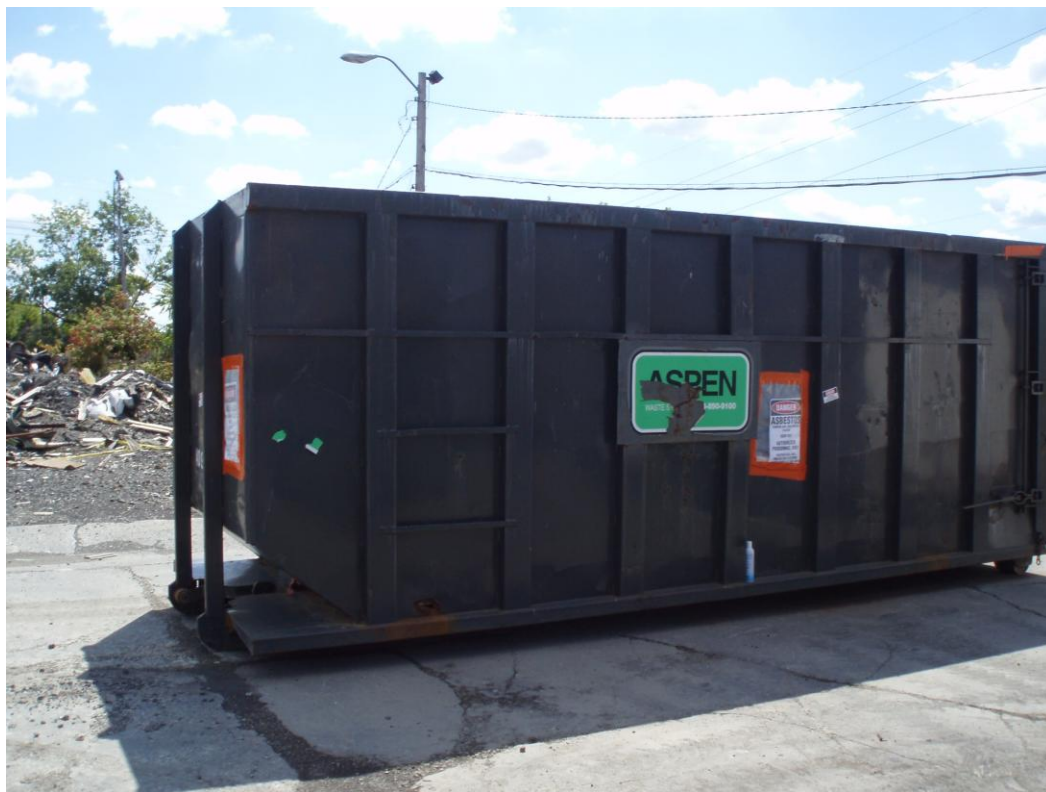
The asbestos waste was staged in an Aspen roll-off box on the south side of the Tank House (see attached photos #013 and #014). Hazardous waste analytical testing was pending for the asbestos waste prior to shipment off-site. I spoke to Mr. Murray and Mr. Rob Pollard (AES Supervisor) concerning the asbestos waste at the conclusion of the August 11, 2011 site visit. I stated that the waste must not be removed from the site without the prior approval from Mr. Chris Cahnovsky.

**Date:** 11 August 2011  
**Time:** 11:28 a.m.  
**Direction:** SE  
**Photo by:** M. Cozadd  
**Exposure #:** 013  
**Comments:** View of roll-off box where asbestos contaminated debris is staged pending hazardous waste analytical testing.

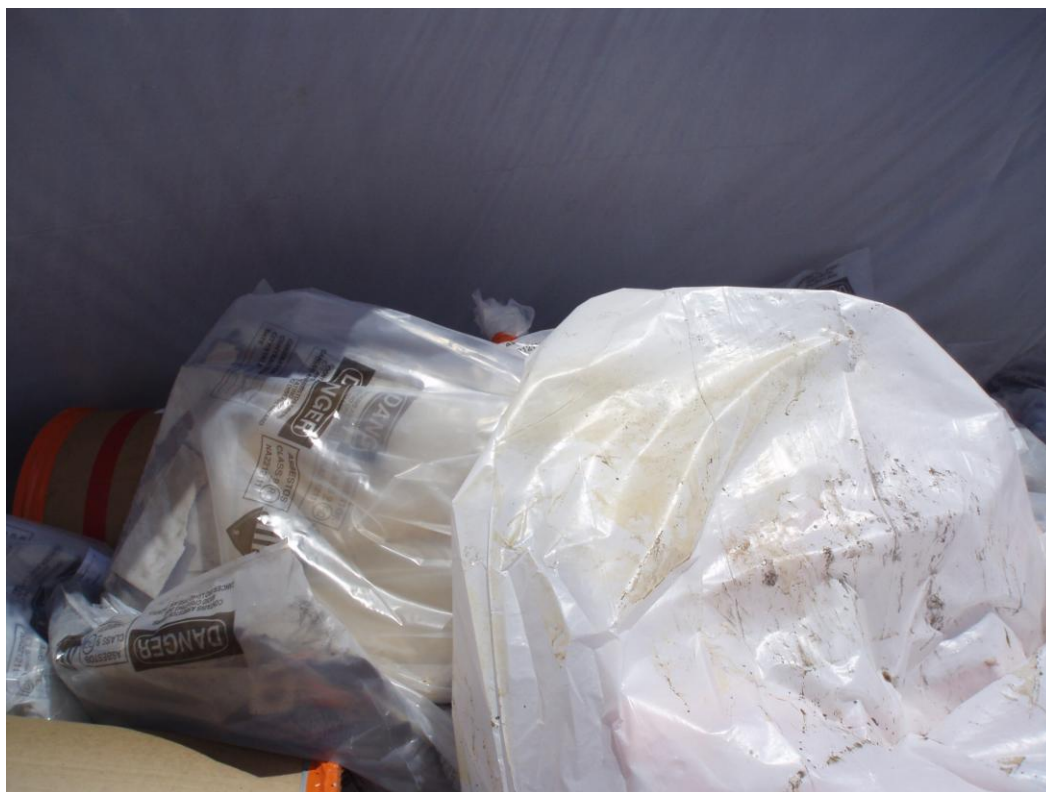
**Date:** 11 August 2011  
**Time:** 11:28 a.m.  
**Direction:** SE  
**Photo by:** M. Cozadd  
**Exposure #:** 014  
**Comments:** Asbestos contaminated debris in roll-off box pending hazardous waste analytical testing.

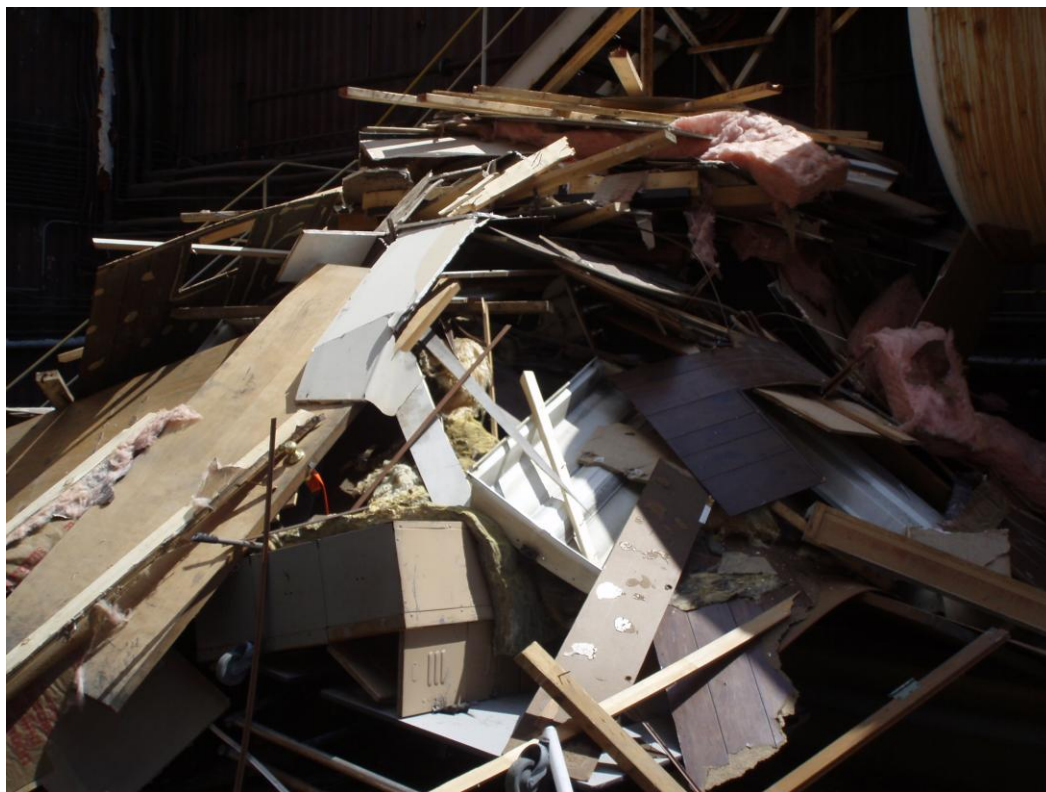
**Date:** 11 August 2011  
**Time:** 11:33 a.m.  
**Direction:** NE  
**Photo by:** M. Cozadd  
**Exposure #:** 015  
**Comments:** Demolition debris from offices in Tank House.

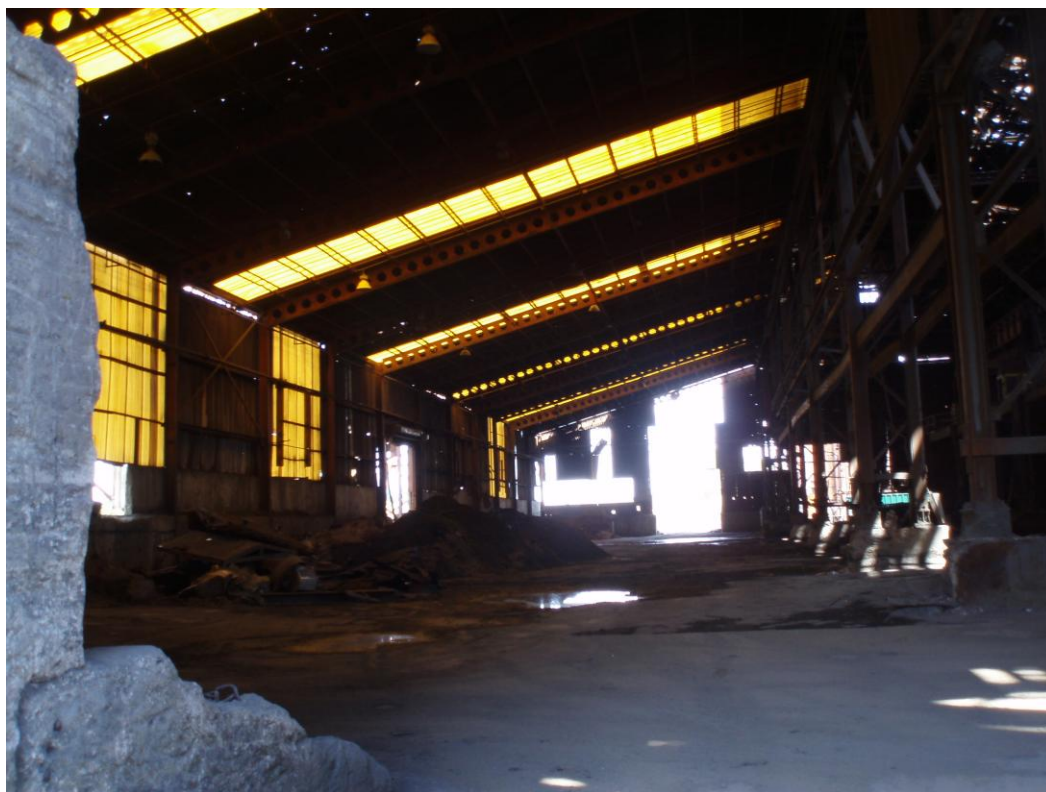
**Date:** 11 August 2011  
**Time:** 11:37 a.m.  
**Direction:** N  
**Photo by:** M. Cozadd  
**Exposure #:** 016  
**Comments:** Interior of Foundry Building as seen from doorway.

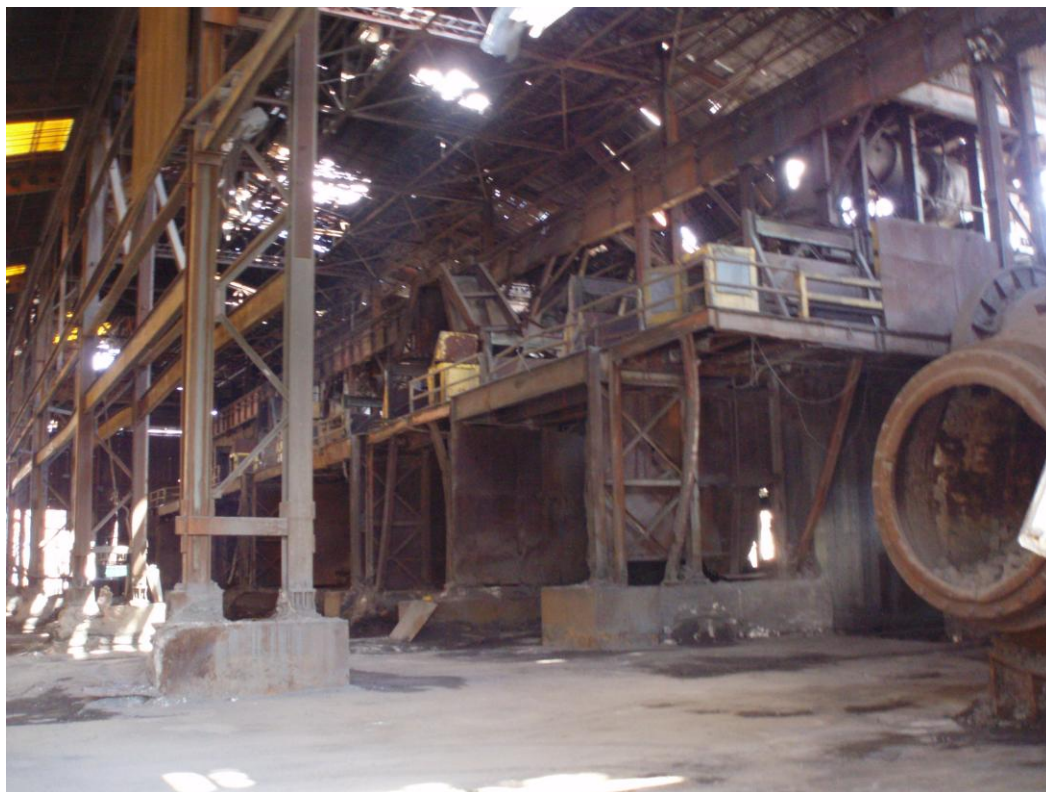
**Date:** 11 August 2011  
**Time:** 11:37 a.m.  
**Direction:** N  
**Photo by:** M. Cozadd  
**Exposure #:** 017  
**Comments:** Interior of Foundry Building as seen from doorway.

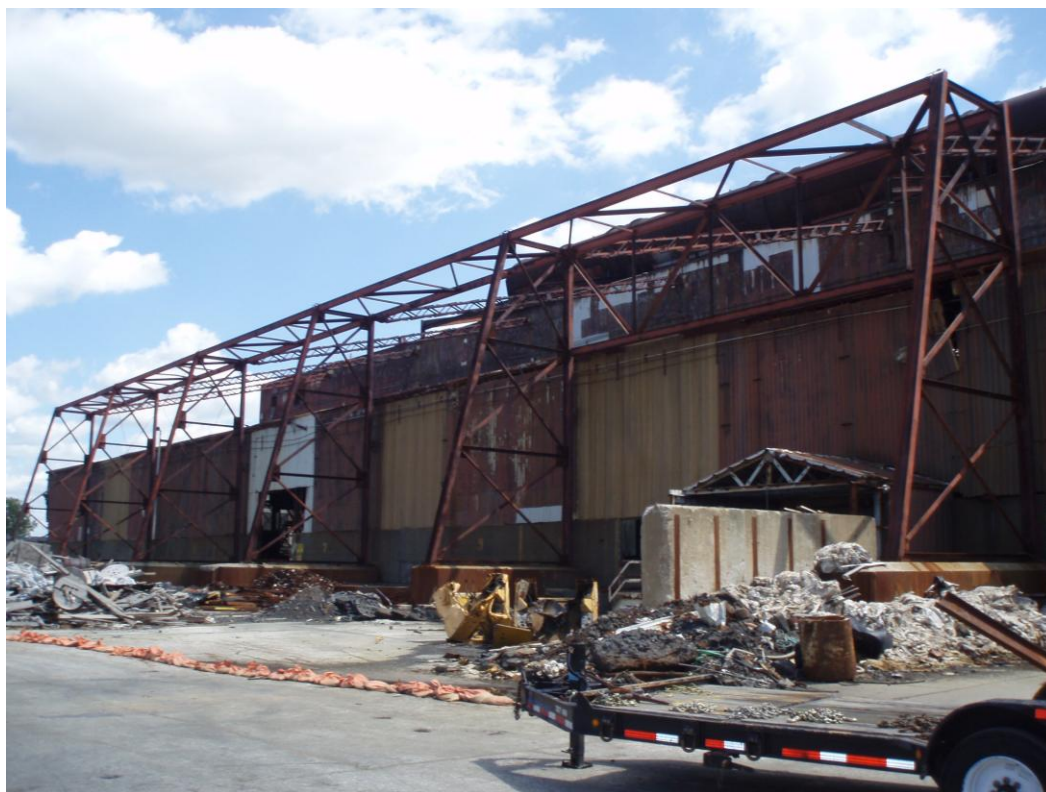
**Date:** 11 August 2011  
**Time:** 11:41 a.m.  
**Direction:** NE  
**Photo by:** M. Cozadd  
**Exposure #:** 018  
**Comments:** West side of Foundry Building.
